# *Museum Fire Burned Area Emergency Response (BAER) Executive Summary*

*Coconino National Forest, Flagstaff, Arizona.  
Prepared by Museum Fire BAER Team  
August 7, 2019*

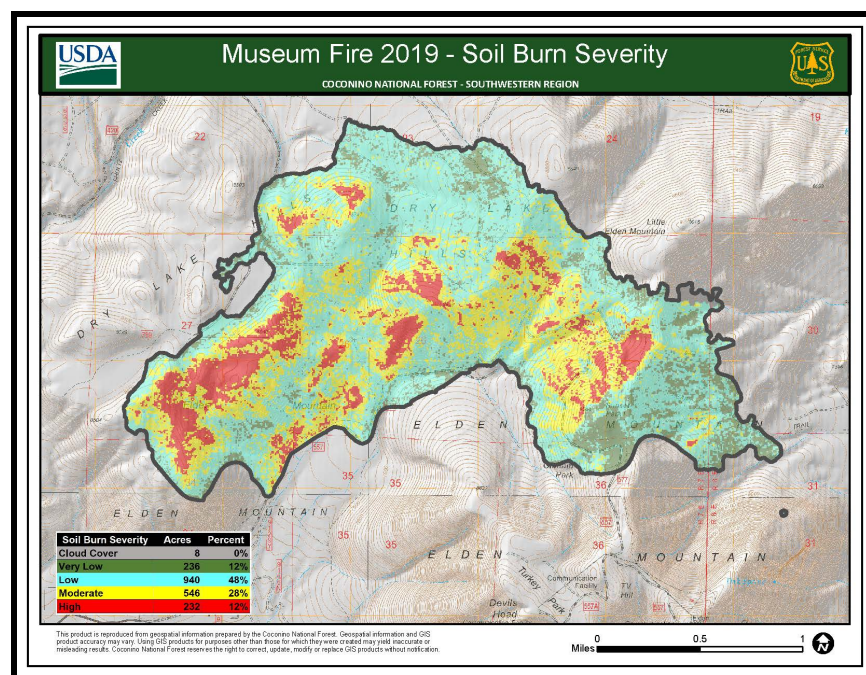
Figure 1. Museum Fire Soil Burn Severity.

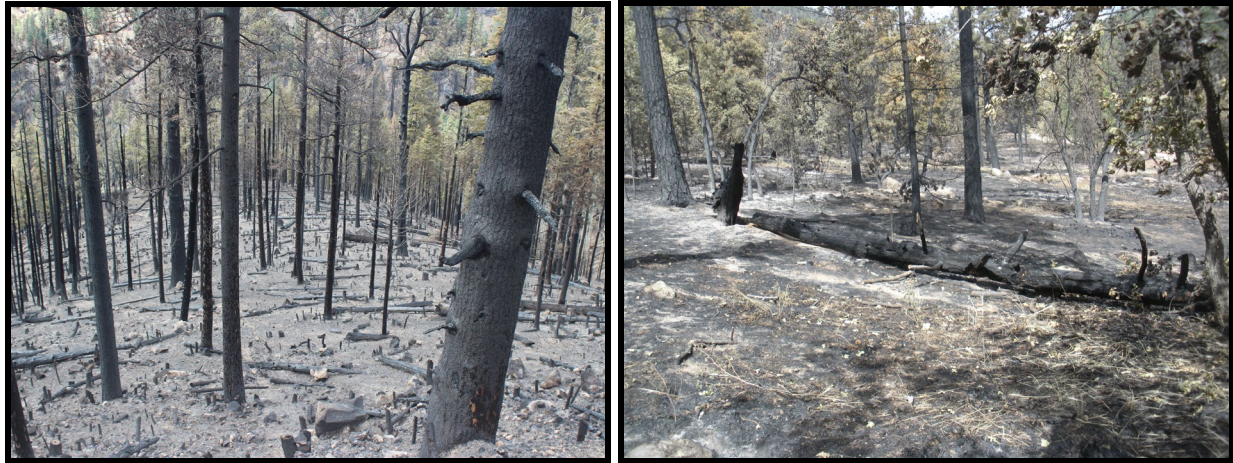
Figure 2. Examples of high (left) and moderate (right) soil burn severities.

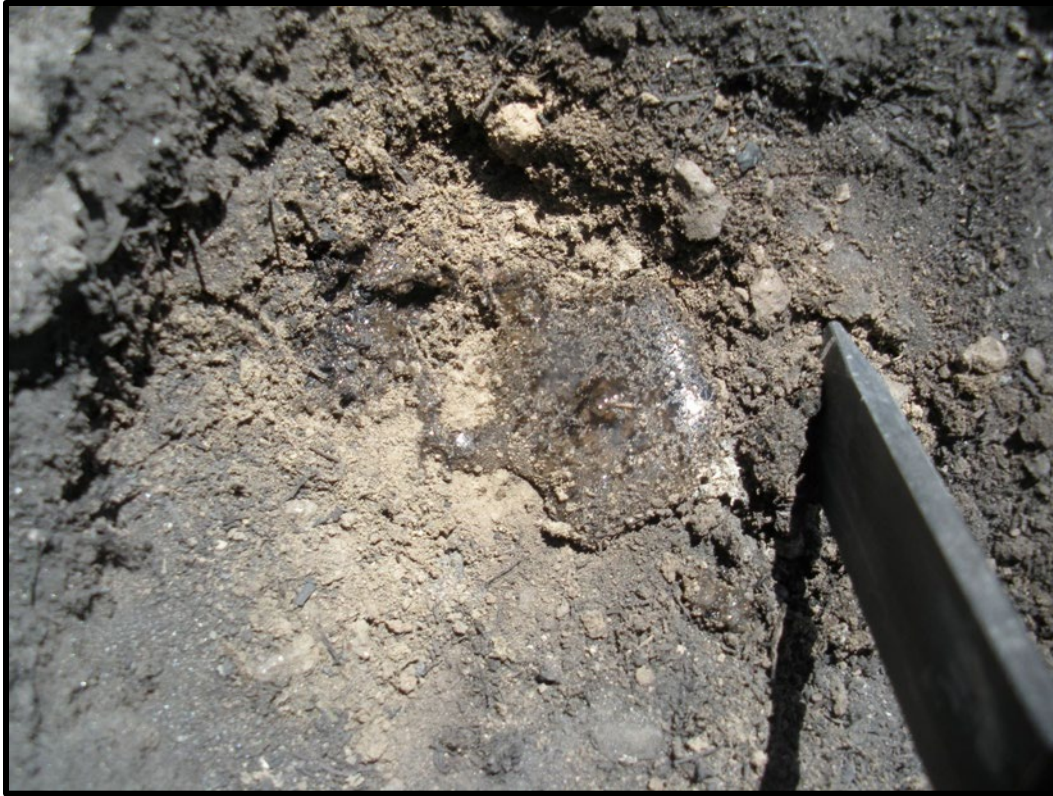
*Figure 3. Example of water repellency occurring in the post fire setting.*

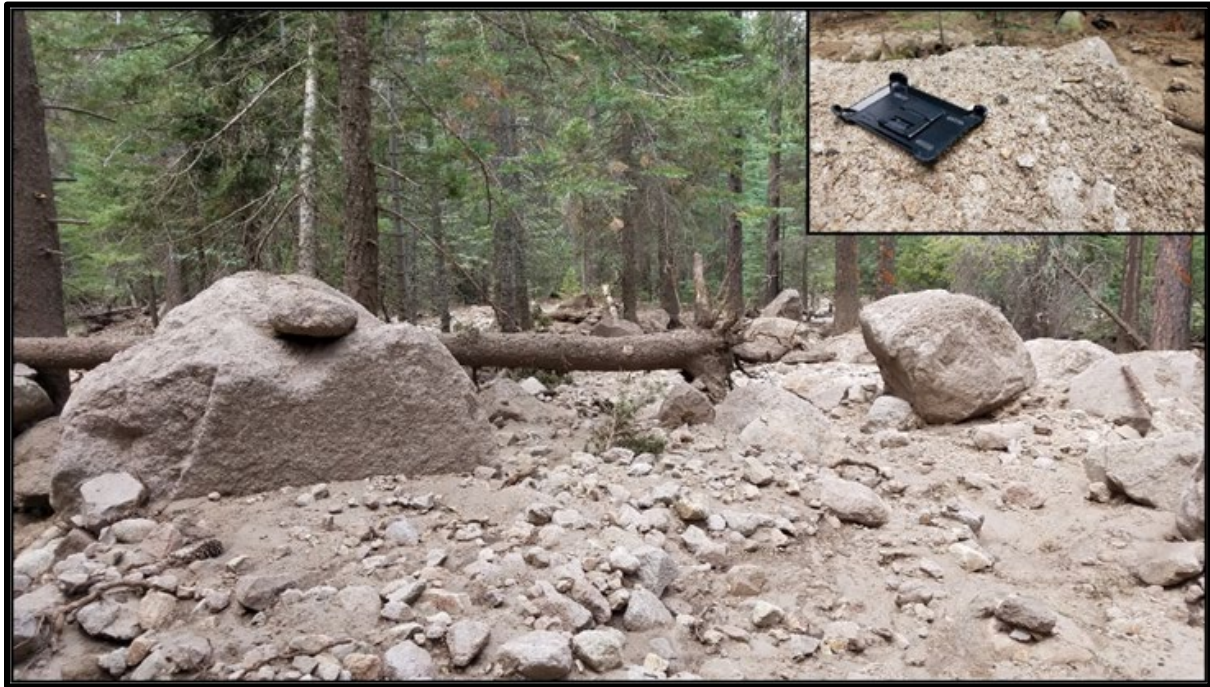
Based on the data available for this hazard assessment, it is very likely that debris flows will occur in the Museum Fire burn scar, particularly if intense rainfall occurs before treatments can be fully implemented. Indeed, one debris flow has already occurred (Figure 4). The consequence of debris flows to critical BAER resources are moderate to major.

*Figure 4. Debris-flow deposit on Upper Oldham Trail from the July 23<sup>rd</sup> storm.*

and channel debris flows. Recommended treatments include wood shred mulch on slopes from 15% to 65%, and several road treatments, including removing culverts, creating rolling dips and drainage structure reinforcement. The risk to structural reinforcement is from scour and not weight loads, so scour protection should be included with the drainage structure reinforcements. Treatments will help reduce surface runoff which in turn will help reduce risks from post-fire debris flows.
